EIS GENERAL HEALTH AND SAFETY INSPECTION OF THE CARNEGIE ESTATE

Notification to the employer, Carnegie College, of conditions and working practices considered to be unsafe or unhealthy and of arrangements for welfare at work considered to be unsatisfactory.

A general inspection was carried out, starting from 2 March 2009, under the auspices of the 'Safety Representatives and Safety Committees Regulations 1997' by the EIS Health and Safety Branch Officer.

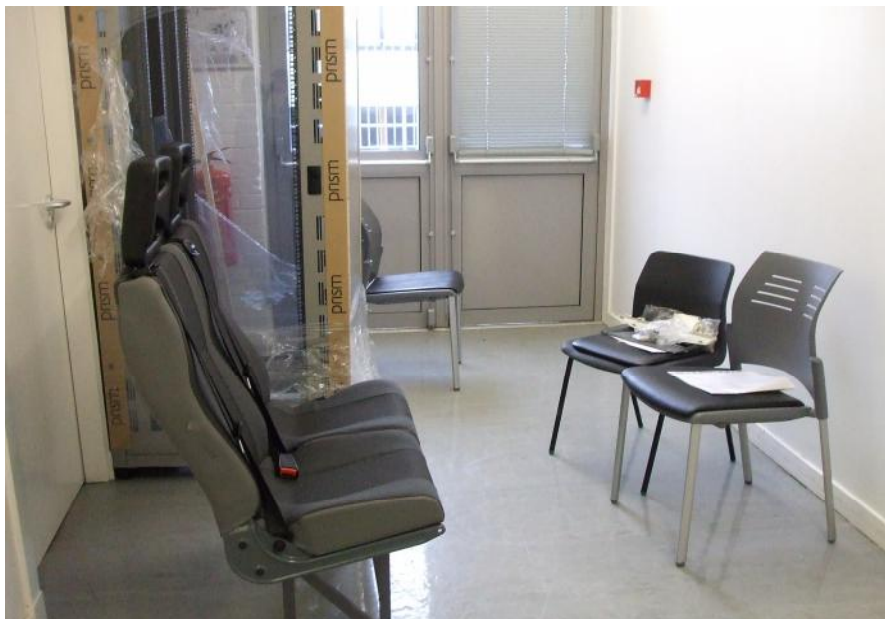
Picture 1

1. Fire hazard at South Gate.

At the South gate the fire door was blocked.
It was blocked by a large metal cabinet, three classroom chairs and seats which had been unloaded from the minibus. (Fire Safety legislation) Please see picture 1.

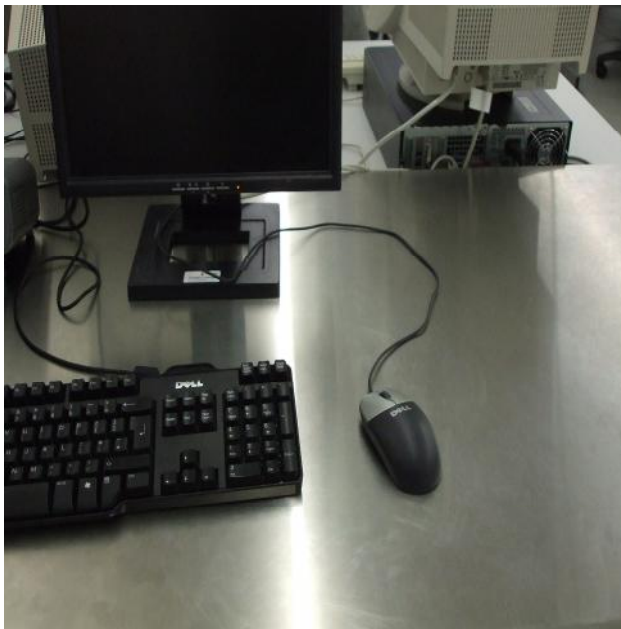
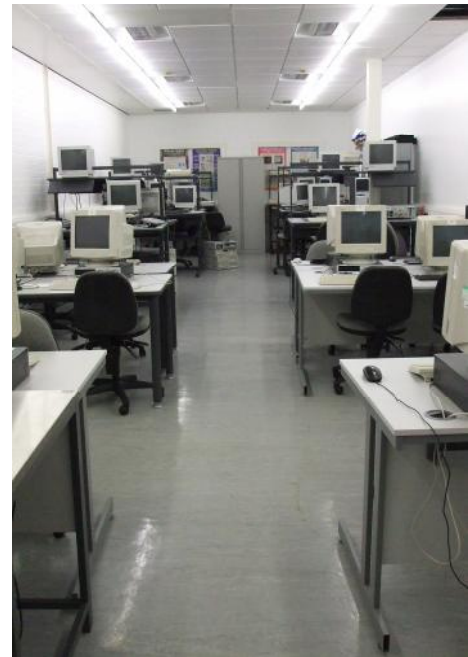
There appears to be no ventilation system fitted in this room which felt airless at the time of the inspection. No means of ensuring the minimum of 8 litres of air per second per person are in evidence. To work in an unventilated room would compromise the health of staff and students; it is particularly unfortunate that the College has converted a store-room into an IT facility, given its additional ventilation requirements. Please see Appendix 1 for information on ventilation requirements. (Building Regulations and Workplace Regulations.)

Flickering, unshielded, fluorescent strip lighting appears very bright. The diffused lights *in situ* are non-operational. The seat height for the work benches do not appear to be ergonomic for adults of average height. (Display Screen Equipment Regulations) There are 31 chairs in the room, which would restrict movement of students in the event of a fire. (Fire safety).

Reflected fluorescent light on to the lecturer's metal desk results in background glare. The appearance of the windowless, airless room with the one exit, metal table and white painted walls resembles a mortuary rather than a classroom. Please see pictures 2 and 3.

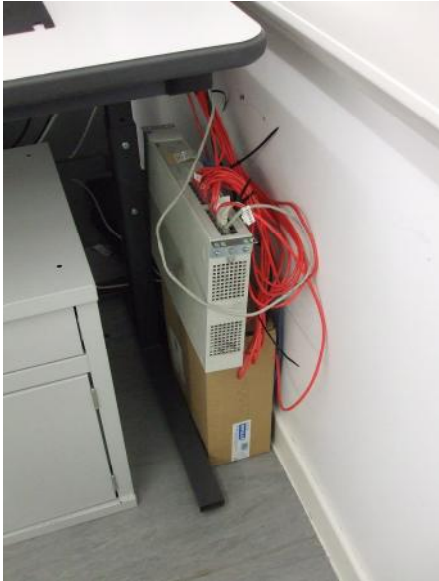
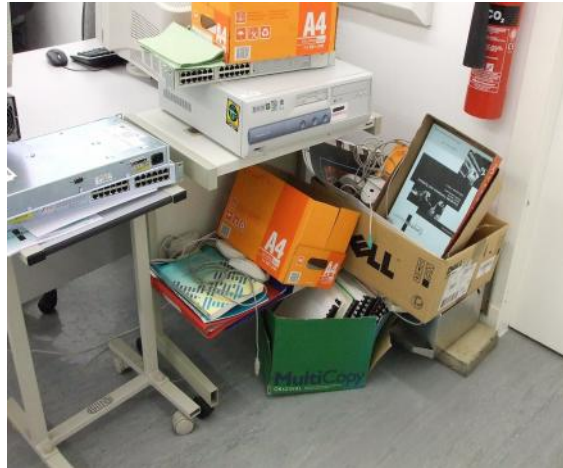
The room has materials stored under one workstation. There is also electrical equipment in operation but not attached to a fixed point. The former equipment was balanced on a cardboard box. These both constitute a fire hazard. Please see pictures 4 and 5.

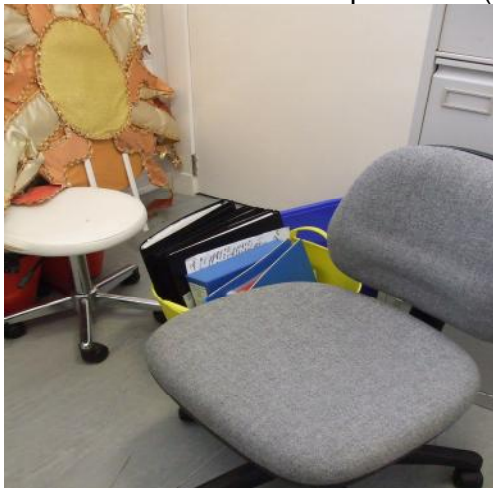
Picture 6

The fire door was blocked by a large quantity of materials making it impossible to get through. Please see picture 6. The door in the corridor was also obstructed. Please see picture 7. (Fire safety)

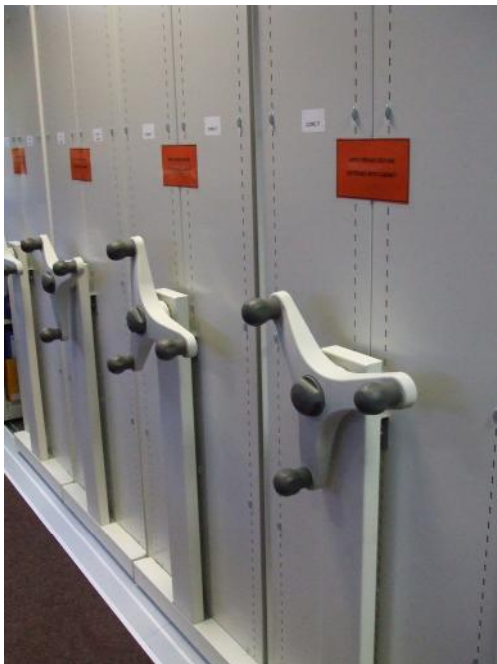
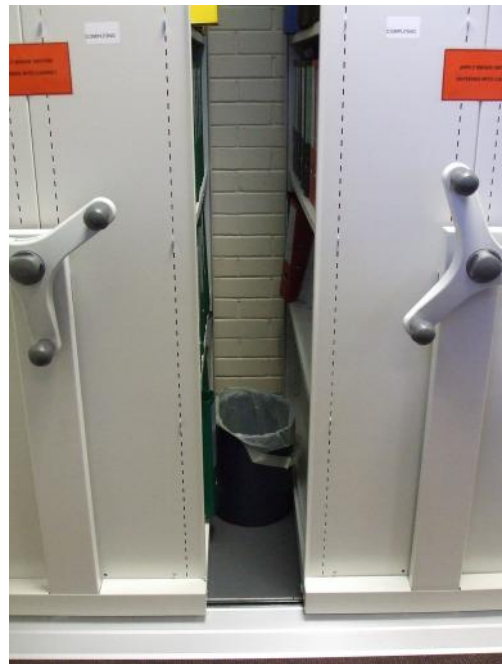
During the inspection, several staff were witnessed using the storage system without locking it first. Once inside, lecturers are not visible to other users who could unwittingly close the storage racks on the prior user. (Please see pictures 7 and 8 showing the latter and what happens if a bucket is left in the storage area and staff close the racking system to access their files.)

Engineering controls, if they could be introduced, would be preferable to relying on busy staff to remember to lock the facility before entering.

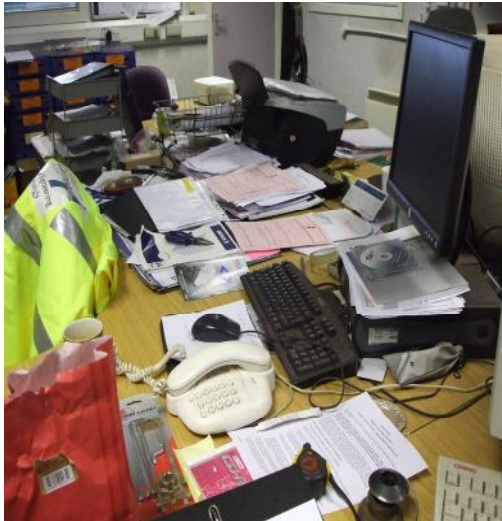
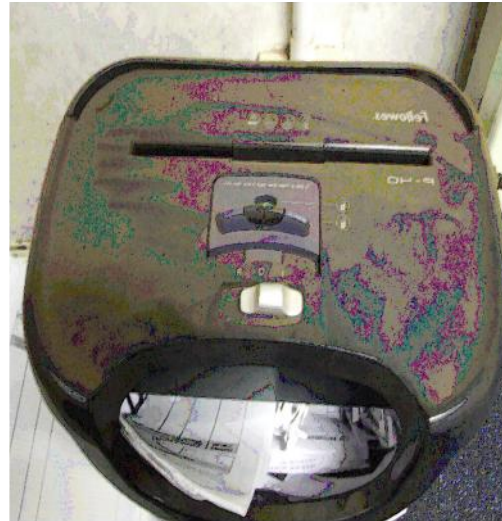
Chairs at computers appear elderly. It was reported that they had been in use since 2000. No DSE risk assessment appeared to have been carried out of the work stations, which (in Fabrication/Welding in particular) are non-ergonomic. (DSE Regs) Please see picture 10. This is compounded by the lack of storage for lecturers' materials and cramped conditions, shown in the same picture. There was a thick layer of dust over equipment in this workroom. Please see picture 11.

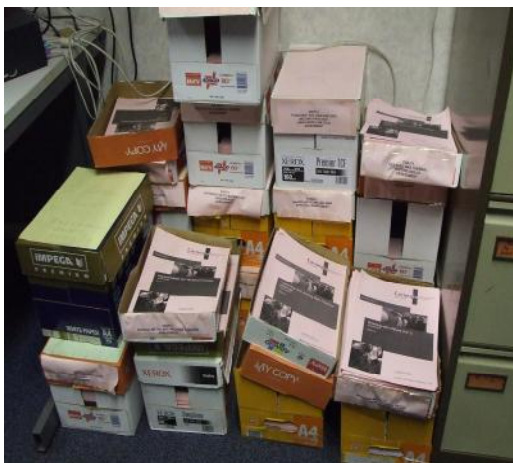
Picture 12

The inadequate storage provided, meant that paper materials are stacked on the floor, constituting a fire hazard. Please see picture 12. There was a number of trailing wires under Mr Y's desk, constituting both a fire and trip hazard. (Fire Regs and Workplace Regs). Please see picture 13.

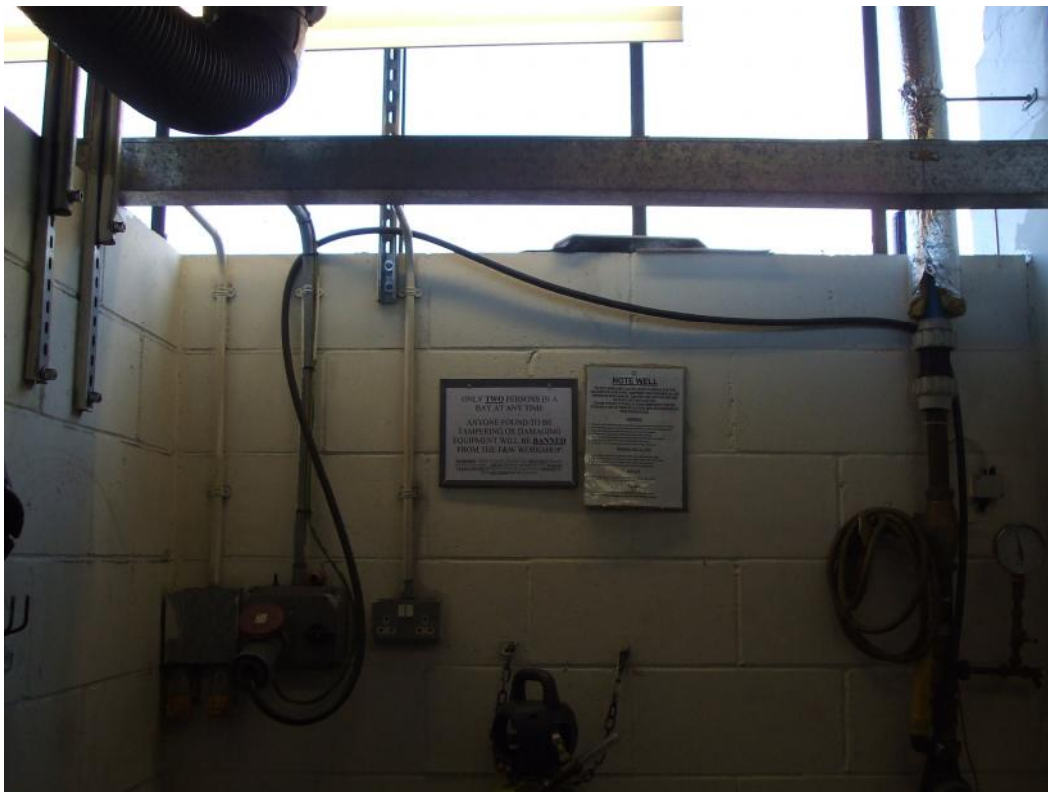
Picture 14

The welding bays (17-23) are dark as lights are not located centrally. Please see picture 14. Without consultation, the bays were also set up for use by left-handed persons only. The resulting arrangement is non-ergonomic for the majority to use. There is also a greater potential for the hose to be showered with sparks. A plate has been built to cover the hose in recognition of this, but it is still hazardous.

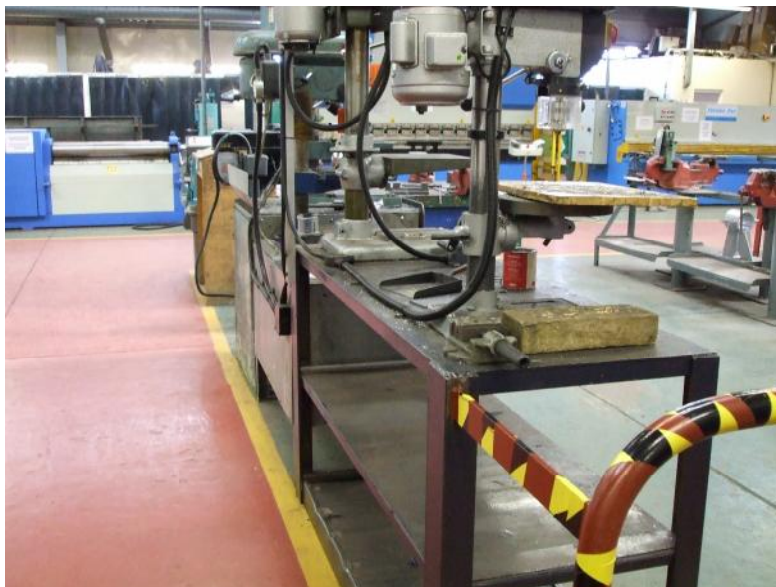
Picture 15.

35.1. The walkway runs adjacent to a set of bench drills with the potential for shards to injure the eye of a passer-by. (PUWER) Please see picture 15

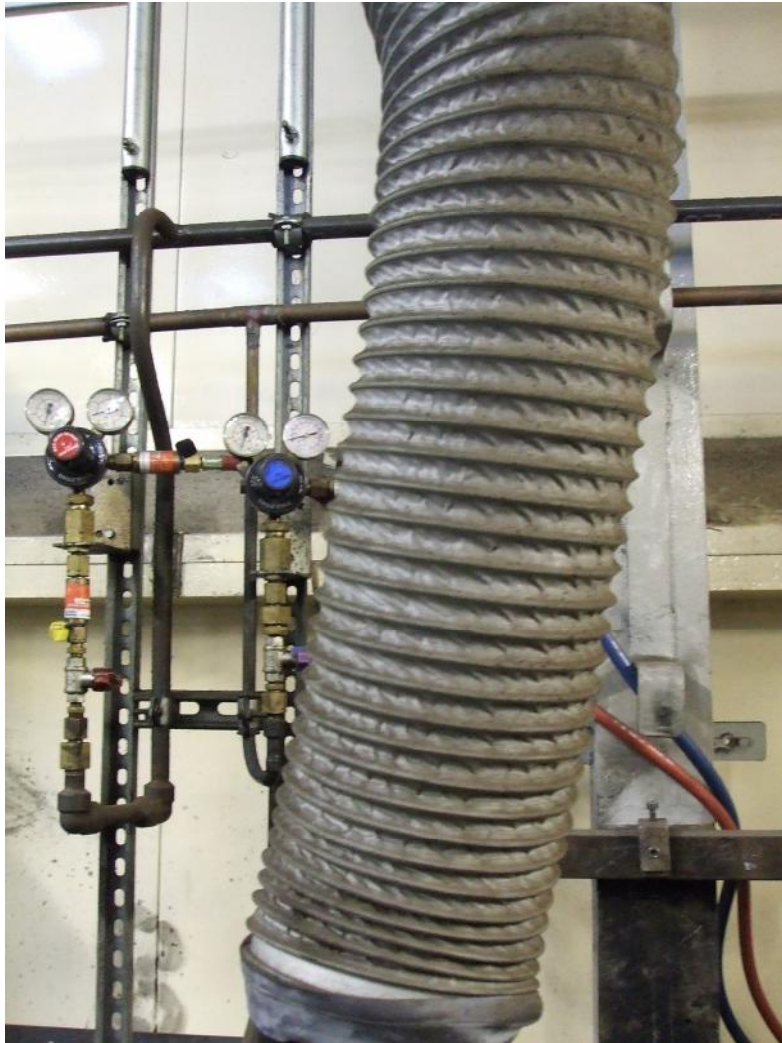
There is a layer of black metallic dust lying above the gas pipes at the extraction system at eye level. This has the potential to cause injury by blowing into eyes, when doors to the workshop are opened, displacing the dust. Please see picture 16.

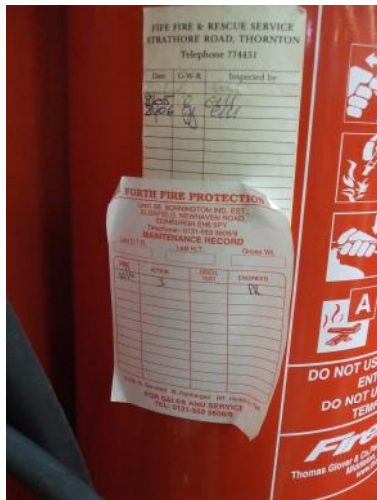
Picture 16

The powder fire extinguisher outside Staff Workroom 2 (Mechanical) has a maintenance record showing October 2006. (Fire Safety Regs) Please see picture 16.

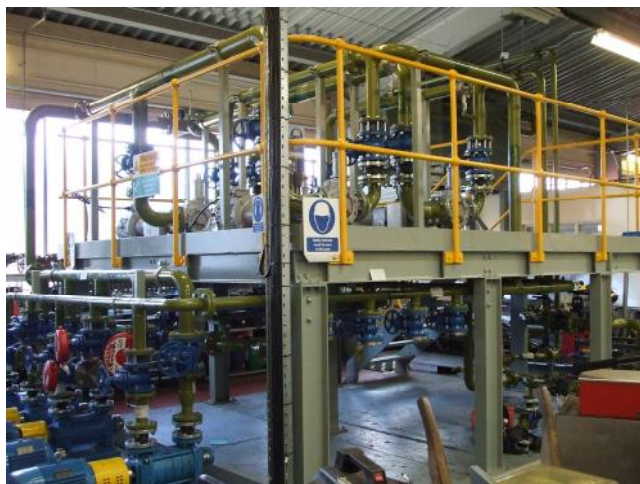
Picture 17

The new maintenance and repair pipe and pump rig in the mechanical workshop requires a slinging beam to avoid manual handling. Please see picture 17 above. At present, staff are using a forklift truck and engine lift (hand operated). However, these are not enough to reach over the safety railing. Therefore, lecturers have to apply physical force in awkward positions. The only risk assessment is of the rig, not of the manual handling operation *in situ*, nor of the individual lecturer with medical issues.

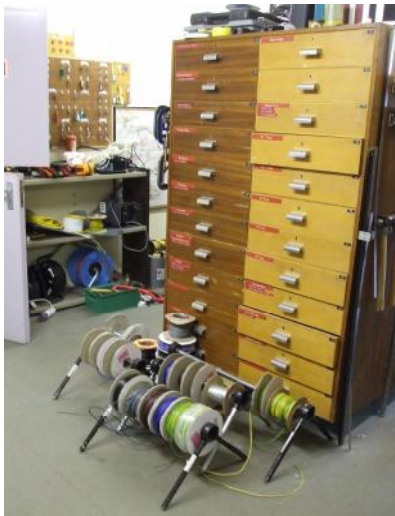
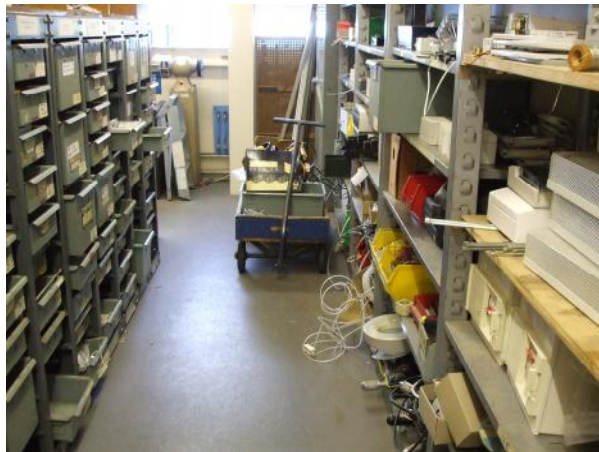
45.1 It was reported by staff that with a new electrical technician in post, trip hazards in the stores are less prevalent. However, at the time of the inspection, trip hazards were in evidence in the stores. Please see pictures.18 and 19.

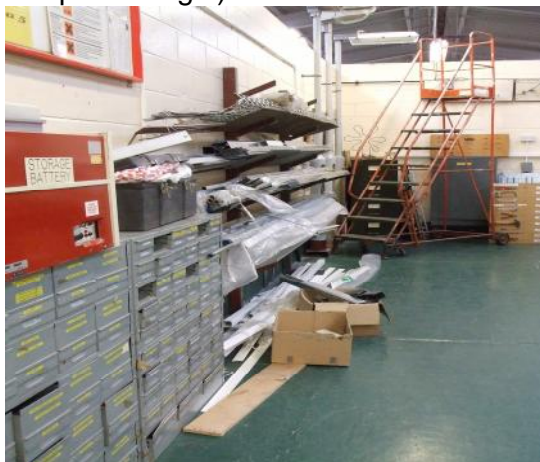
Picture 20

45.2 Area 5 had a mobile stairway and boxes left on the floor. Please see picture 20. (Workplace Regs.)

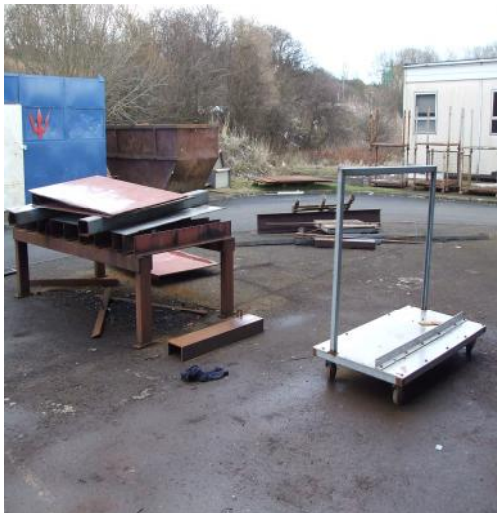
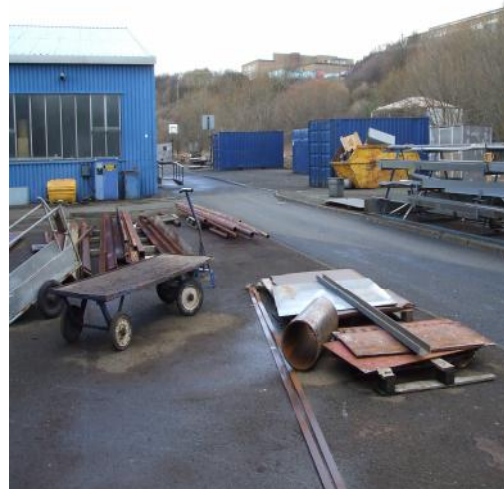
The yard outside the fire exits is littered with unwanted scrap and pallets, etc. (Please see pictures 21 and 22). The rubbish around the campus constitutes a fire hazard. There do not appear to be clear lines of responsibility for clearing this area up.

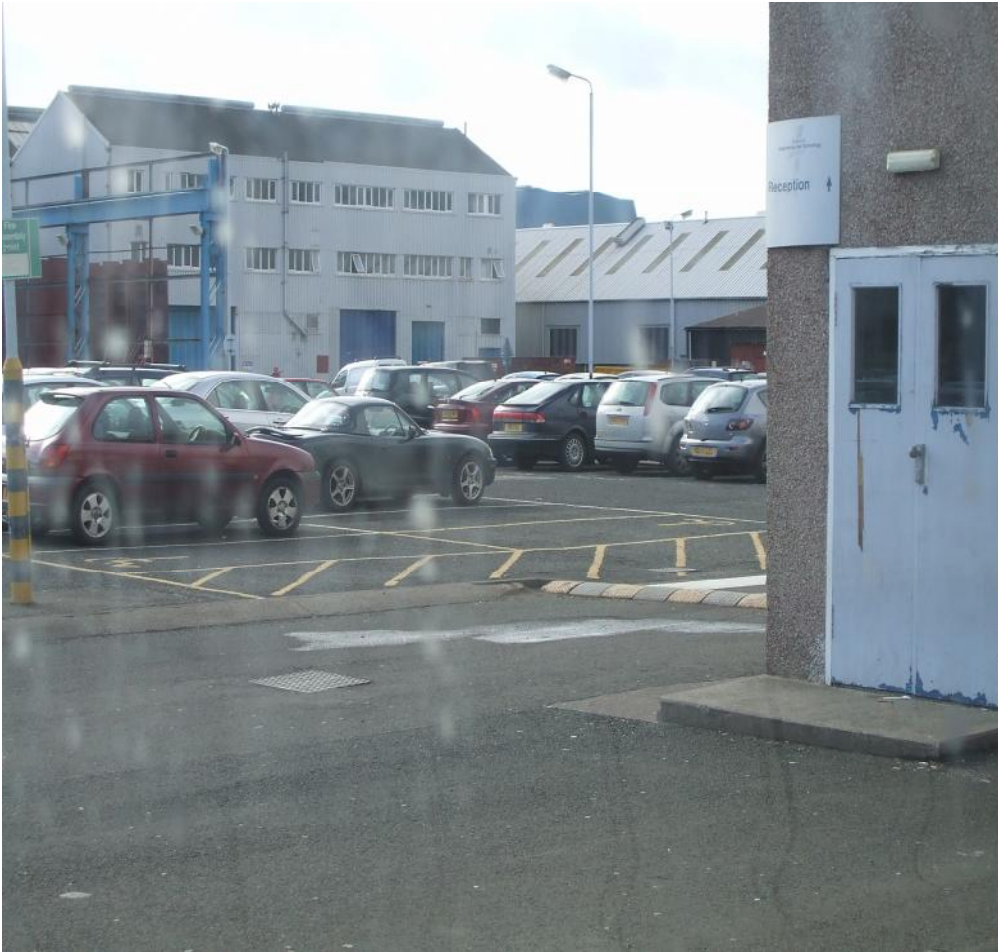
Picture 23

Staff and students are not kept separate from moving traffic around the building. Please see picture 23. (The front of the building was subsequently marked for pedestrians after an EIS hazard alert was submitted by the author of this report, following a visit by the author of this report). However, there are no designated walkways at the back of the building, and road-crossing points are not provided. (A student has subsequently been injured by a vehicle in this area.) Roads are not in good condition and lighting at the sides and back of the building is inadequate.

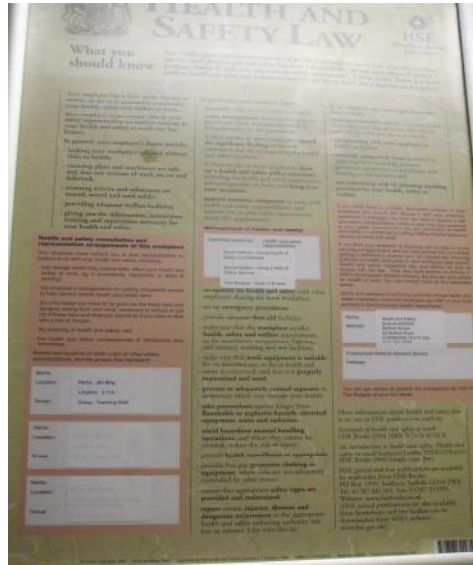
Picture 24

The laminated Health and Safety Law poster was on display. Unfortunately, it had not been updated by the College to inform academic staff who their Health and Safety Representative was, from the EIS AGM in January 2009. Please see picture 24.

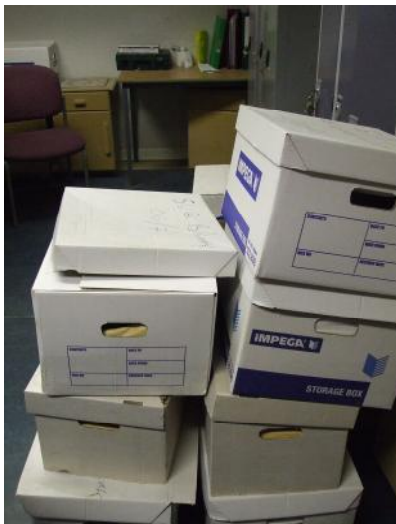
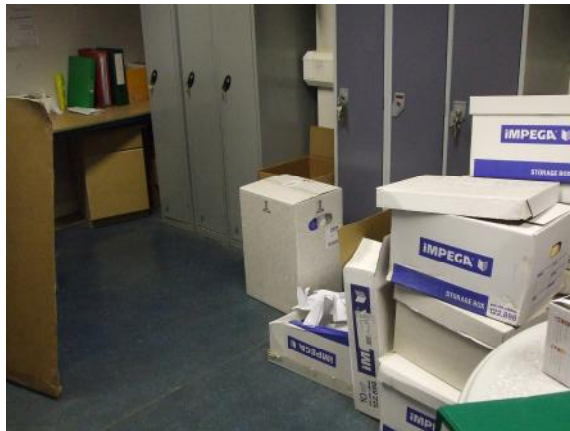
There was a well-stocked first aid box. However, first aid facilities were cramped, occupying a desk in a small corner of a room where boxes were stored, constituting a trip hazard. (First Aid Regs.). Please see picture 25 and 26. There had been an occasion on 20 September 2007, when three students had been injured carrying out different tasks/activities (one outside the building), and all arrived for first aid treatment within five minutes of each other. Each injury resulted in the students being taken to hospital. At the time of the inspection there was only one first aider, so no cover is possible. However, a part-time classroom assistant will be available as a first aider shortly.

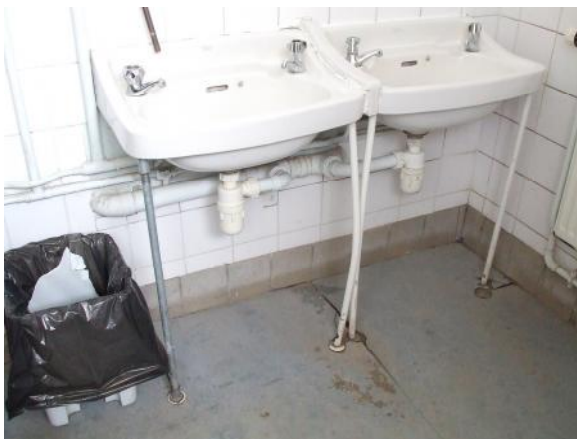
Picture 27

52.1 The male toilet has a broken floor surface making it difficult to keep clean. (Workplace Regs) Please see picture 27.

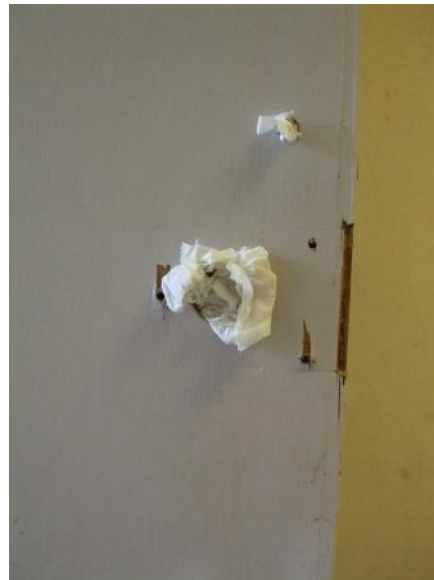
Picture 28

52.2 The disabled toilet has a hole in the door stuffed with toilet paper. Please see picture 28 above. (Dignity at Work and Workplace Regs).

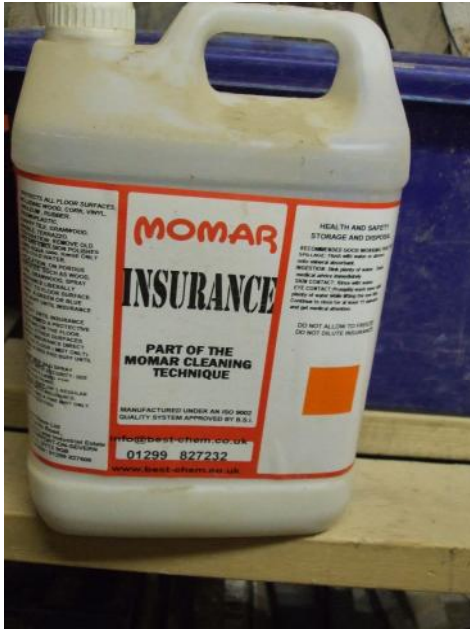
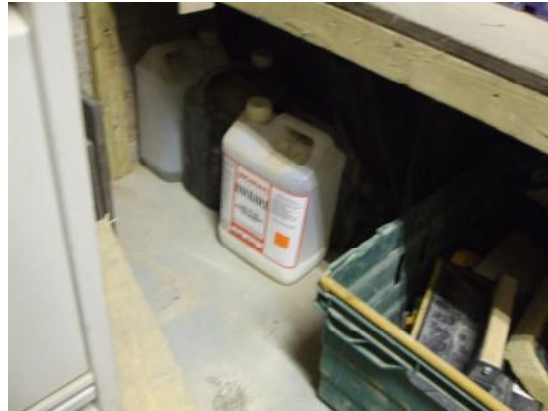
The stores were very tidy at the time of the inspection. However, a plastic bottle of chemical cleaner have been left on a lower shelf by a previous cleaning firm. Instructions on the label indicate that if the substance comes into contact with a person's eyes, they must rinse for 15 minutes and seek medical help immediately. As the product is not in use but is hazardous, it may be worth considering safety disposing of it. (COSHH Regs). (Please see pictures 28 and 30)

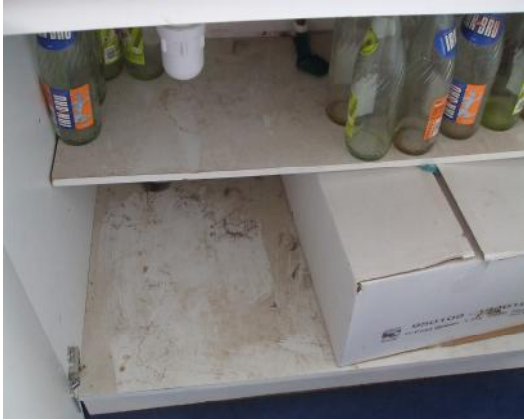
Picture 31

Catering facilities on site are very basic. The underneath inside of the sink was dirty at the time of inspection. (Workplace Regs) Please see picture 31. Cardboard and other materials were stored next to the sink, making the floor difficult to clean. Please see picture 32.

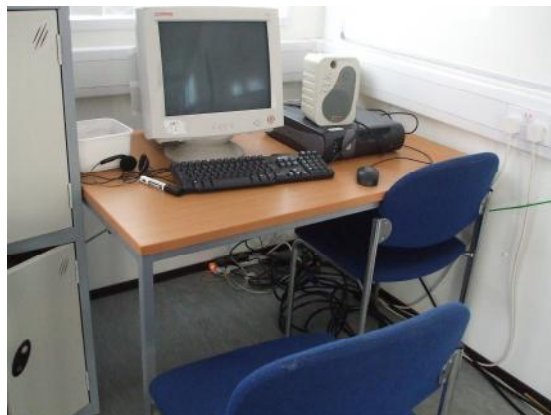
Picture 33

The chair for the staff member's use at the computer is non-adjustable. (DSE Regs.) There were also loose wires underneath, a potential trip hazard. (Workplace Regs) Please see picture 33.

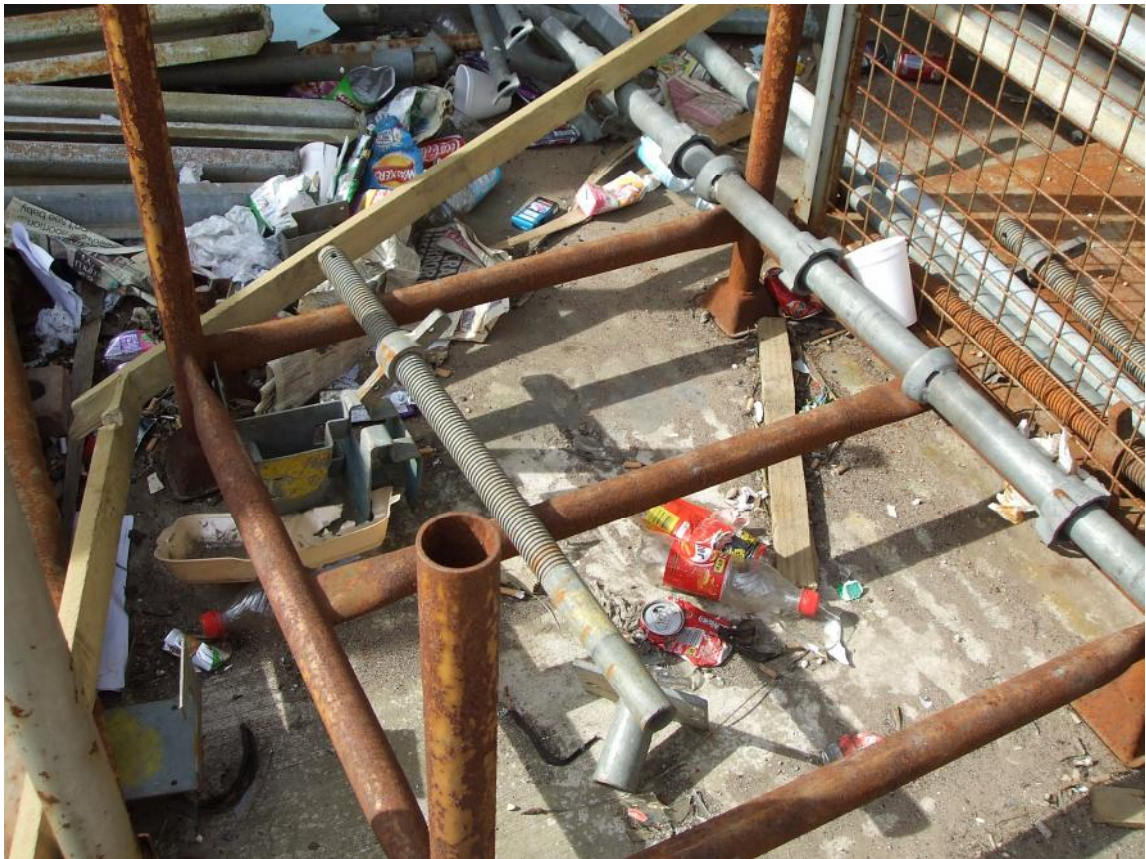
Picture 34

The backyard was untidy, constituting fire and trip hazards. Please see picture 34. Staff reported that the outside area had recently been treated to reduce the number of rats that had been seen there. However, unless cleared, it would be an environment where vermin would flourish.

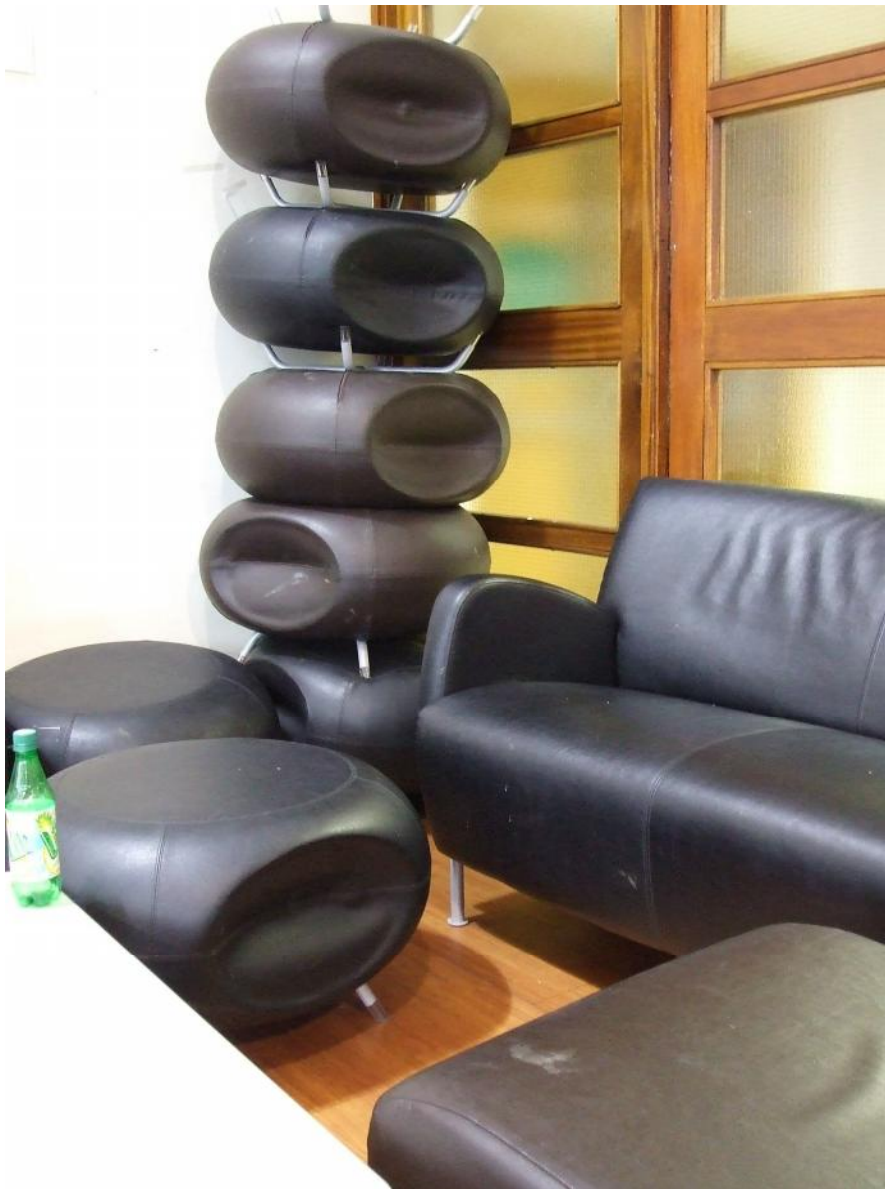
Picture 35

A quantity of seating was piled above head height in a corner of the canteen at the time of the inspection. Please see picture 35. This is an unstable arrangement and could easily be dislodged, so that heavy seating falls onto staff or students sitting in the adjacent chairs, potentially causing injury. Please see picture 35.
